RAILROAD COMMISSION OF TEXAS

RE: Weesatche Project, Goliad County

Uranium Exploration Permit No. 123C

URANIUM EXPLORATION INSPECTION REPORT

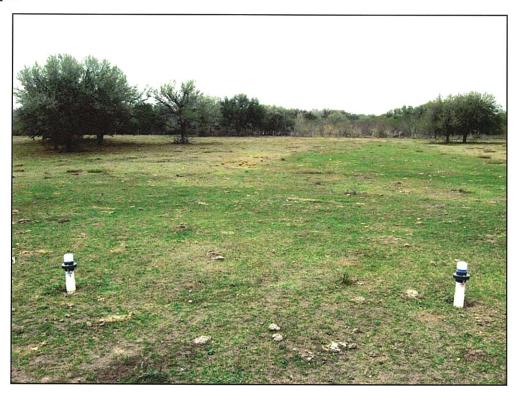
Drilling location site restorations located on the Schrade, Colbert, South Colbert and Abramite properties were examined during this inspection of UEC Permit No. 123C. Persistent drought conditions have slowed the advancement of re-vegetation, but recent local precipitation has somewhat alleviated conditions. Photos 1-4 document the advancement of re-vegetation at previously inspected cased wells RBLD-3, RBLD-5, RBLA-5 and RBLA-2 on the Abramite lease in the period from 3-25-09 and 8-26-09. Vegetation change near cased well RBL3-A on the neighboring Schrade property is visible in Photos 5-6 during the period from 11-18-08 to 8-26-09. Essentially unnoticeable are numerous previously inspected exploration borehole drilling locations in the area.

Photo 1: Site restoration at cased wells RBLD-3 and RBLD-5 on 3-25-09.

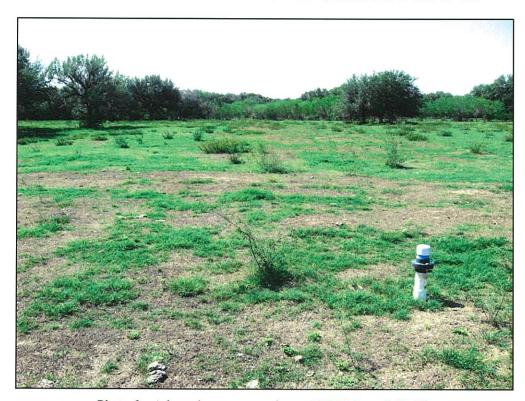
Photo 2: Advancing re-vegetation at RBLD-5 on 8-26-09.

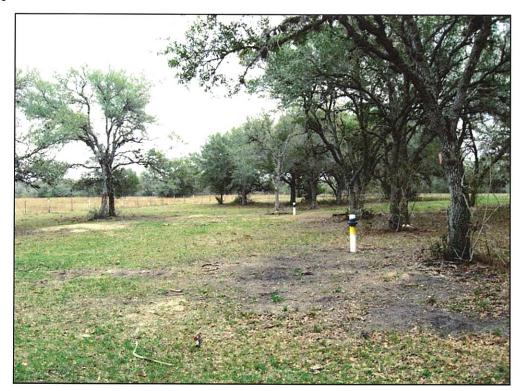
Photo 3: Cased wells RBLA-5 and RBLA-2 on 3-25-09.

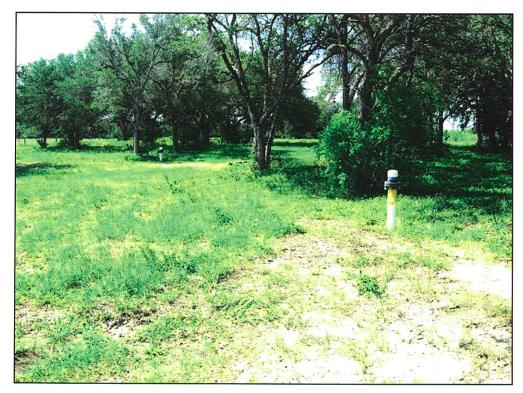
Photo 4: Re-vegetation at RBLA-5 and RBLA-2 on 8-26-09.

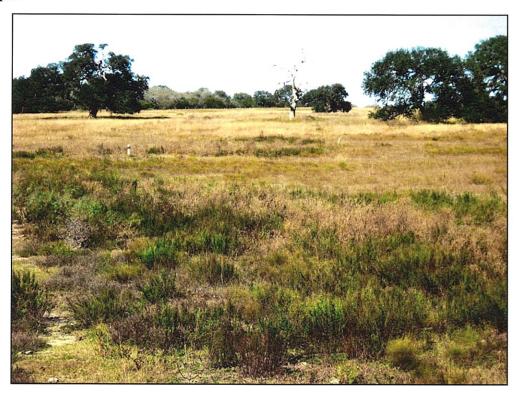
Photo 5: Cased well RBL3-A on Schrade property on 11-18-08.

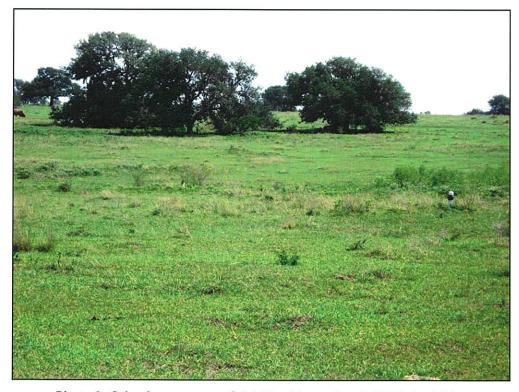
Photo 6: Schrade property on 8-26-09 with cased well RBL3-A visible.

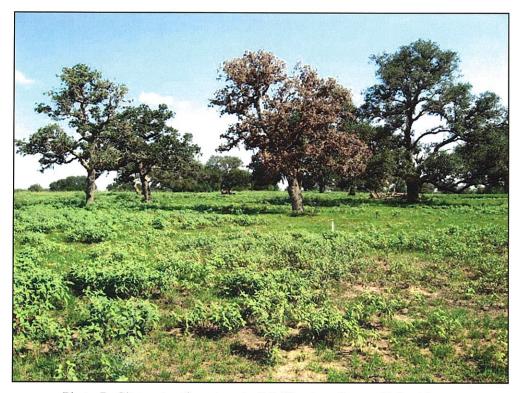
Previously inspected exploration borehole drilling locations on the Colbert and South Colbert are seen in Photos 7-11. No subsidence or incomplete restorations were noted in these areas. A mud pit exhibiting some evidence of subsidence was found on the Abramite property as seen in Photo 12. UEC representative James Gale stated that the problem area would be repaired and equipment to do so is present on the permit.

Photo 7: Site restoration at marked drilling location on Colbert lease.

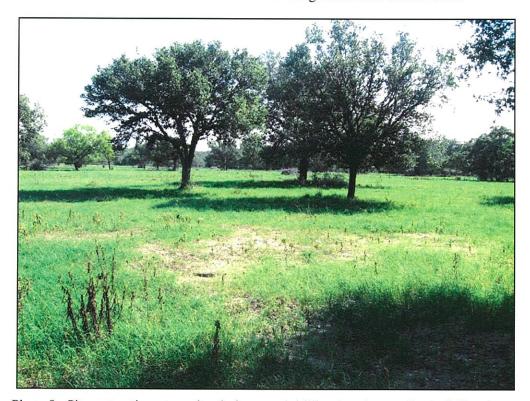
Photo 8: Site restoration at previously inspected drilling location on South Colbert lease.

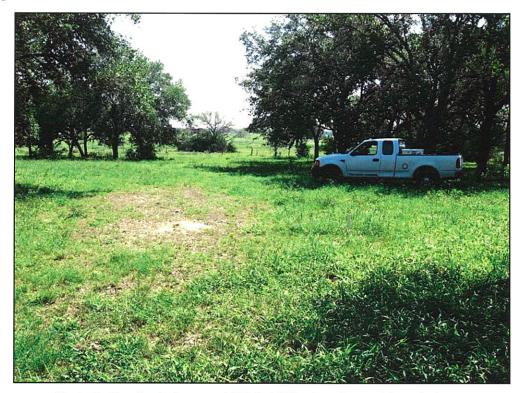
Photo 9: Previously inspected CD-2 drilling location on Abramite lease.

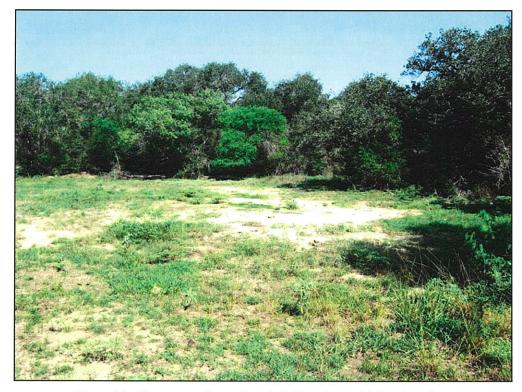
Photo 10: Site restoration at South Colbert lease drilling location.

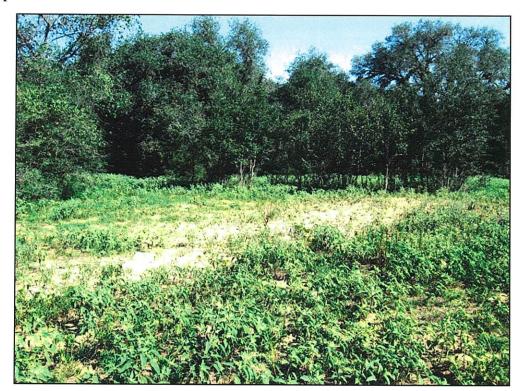
Photo 11: Site restoration at South Colbert drilling location.

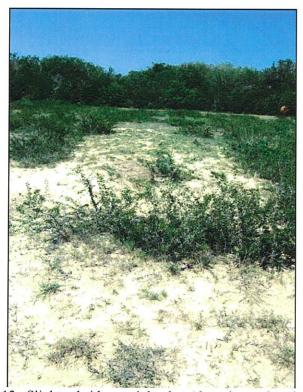
Photo 12: Slight subsidence sighted at Abramite exploration site.
